Surface water key to success

Case study: Esperance Downs Research Station (EDRS)

Location: 28 km north of Esperance, Western Australia

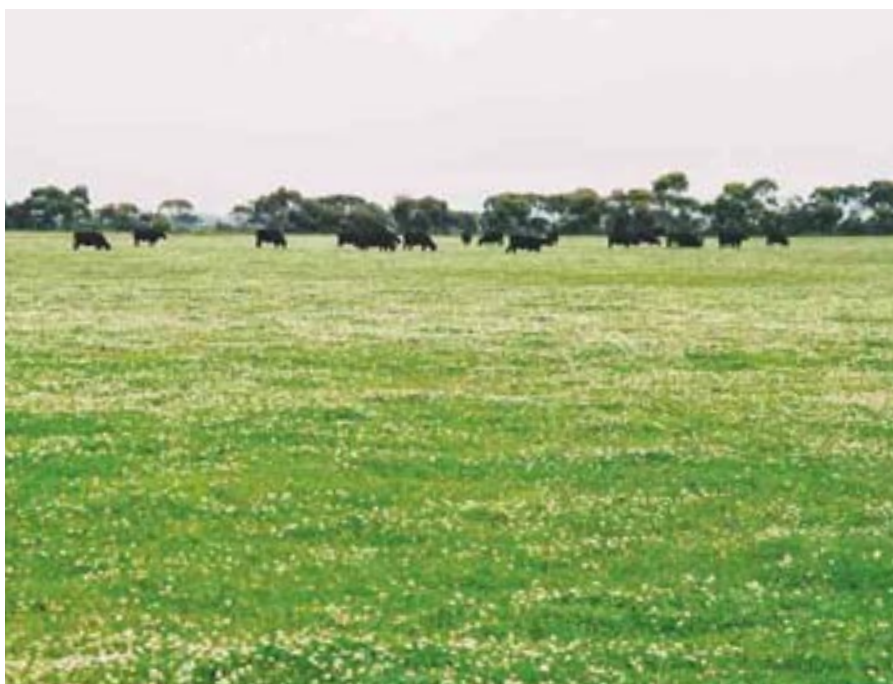
Aberdeen Angus cattle graze on balansa clover pasture that was 20% salt scalds and dominated by barley grass before the surface drains were installed

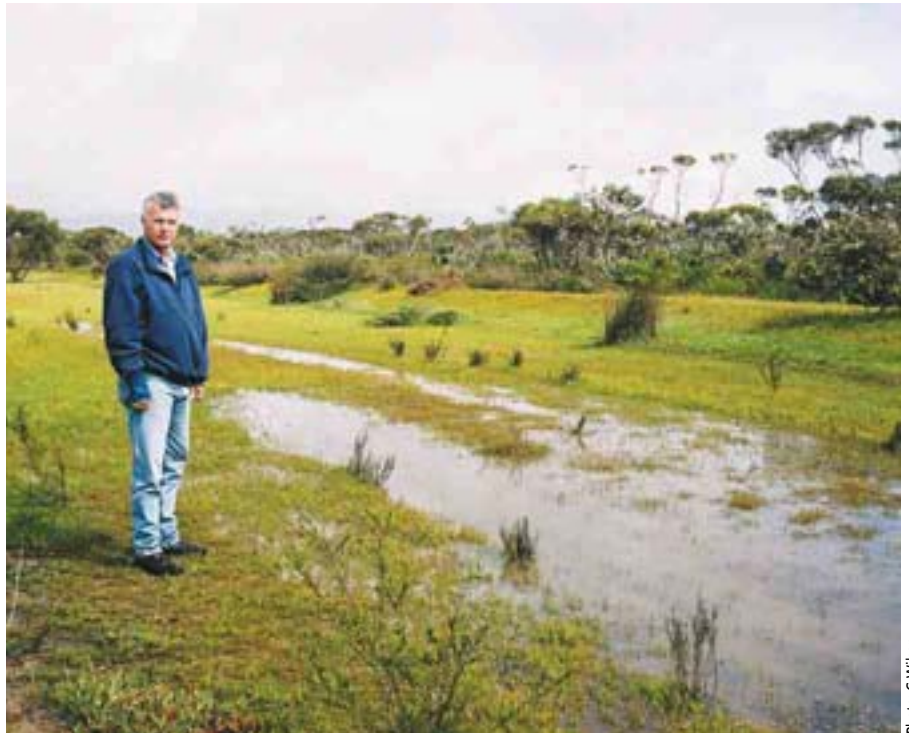
EDRS manager Colin Norwood checks a grassed waterway that takes excess surface water out of grazing land and into nearby remnant bush

Construction, reconstruction and realignment of surface drains occurred from 1991 to 1993, followed by planting of trees, perennials and new fencing. Using a scraper, the main 'U' drain was realigned and deepened along with additional feeder 'W' drains so that water would flow safely and evenly along flat-bottomed channels without ponding. These were considered "overkill" by some observers when first installed, but have more than justified the effort.
