PASTURE MIXES FOR SALINE AND WATERLOGGED SITES – INVERELL

SUSTAINABLE GRAZING ON SALINE LANDS

Case study – Inverell

FARMER: NEIL KAUTER, 'FOREST HILL', BANNOCKBURN, NEAR INVERELL, NSW

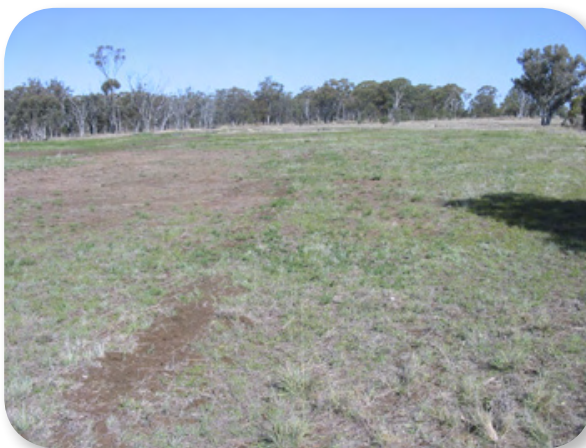
Before: The Bannockburn site before establishment of the saltland pasture. Bare saline scalds are clearly visible and have remained so for many years.

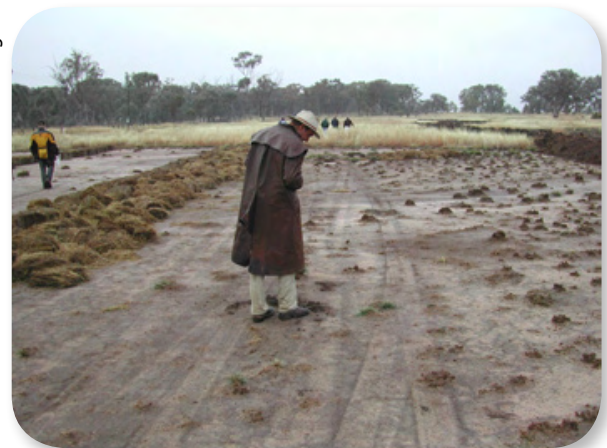
Before: Landholder Neil Kauter inspects the saltland area in June 2004 before the establishment of a salt-tolerant pasture. A mulch is about to be applied to the scalded, bare soil areas in an attempt to reduce the evaporative concentration of salt at the soil surface.

Applying a mulch of forage sorghum and native grass stubble to scalded, bare areas greatly improved the growing conditions for pasture species. Mulch significantly reduced the evaporative concentration of salt at the soil surface and helped form a better seed bed for germination.

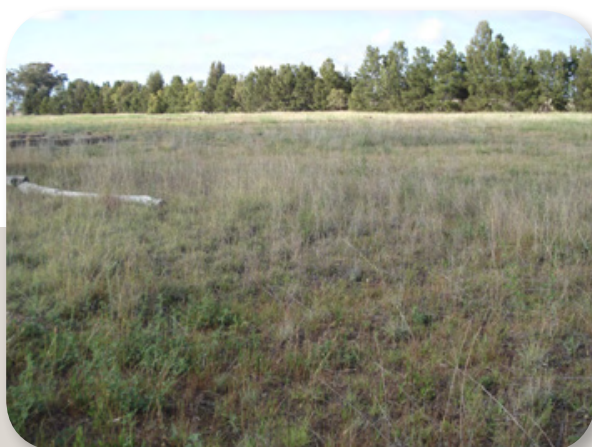
After: The site in spring 2006. A corridor of salt-tolerant trees was planted above the site in the 1980s as an attempt to increase water use and reduce groundwater discharge within the lower landscape.

A line of salt-tolerant trees was planted directly above the site in the late 1980s in an attempt to intercept excess groundwater before it reached the saltland (discharge) area.

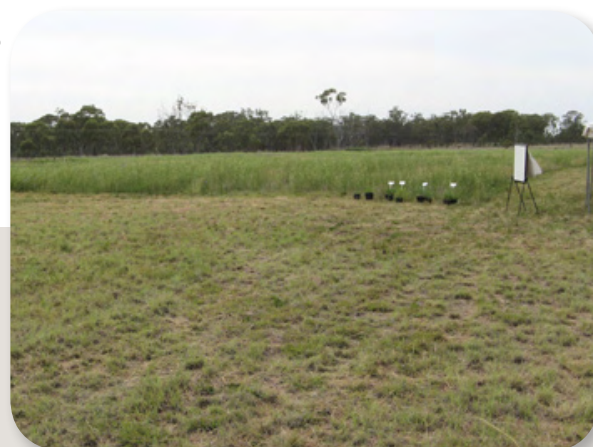
After: Saltland pasture in December 2006. Some species, including Rhodes grass and Melilotus, have naturalised across the site as a result of previous attempts to revegetate the area. Sowing a 'shotgun mix' of species has enabled some plants to find their own niches in suitable areas.

Some pasture species performed better in certain areas than in others. This was a result of the high variability in salinity readings across the site. To account for this soil variation a 'shotgun mix' of saltland pasture species was chosen.

Tall wheatgrass and Rhodes grass tended to dominate the more saline areas. Tall fescue survived within the rip lines.
